**United States Air Force
611th Air Support Group/
Civil Engineering Squadron**

Remedial Investigation and Feasibility Study

**Oliktok Point Radar Installation,
Alaska**

ICF Technology Incorporated

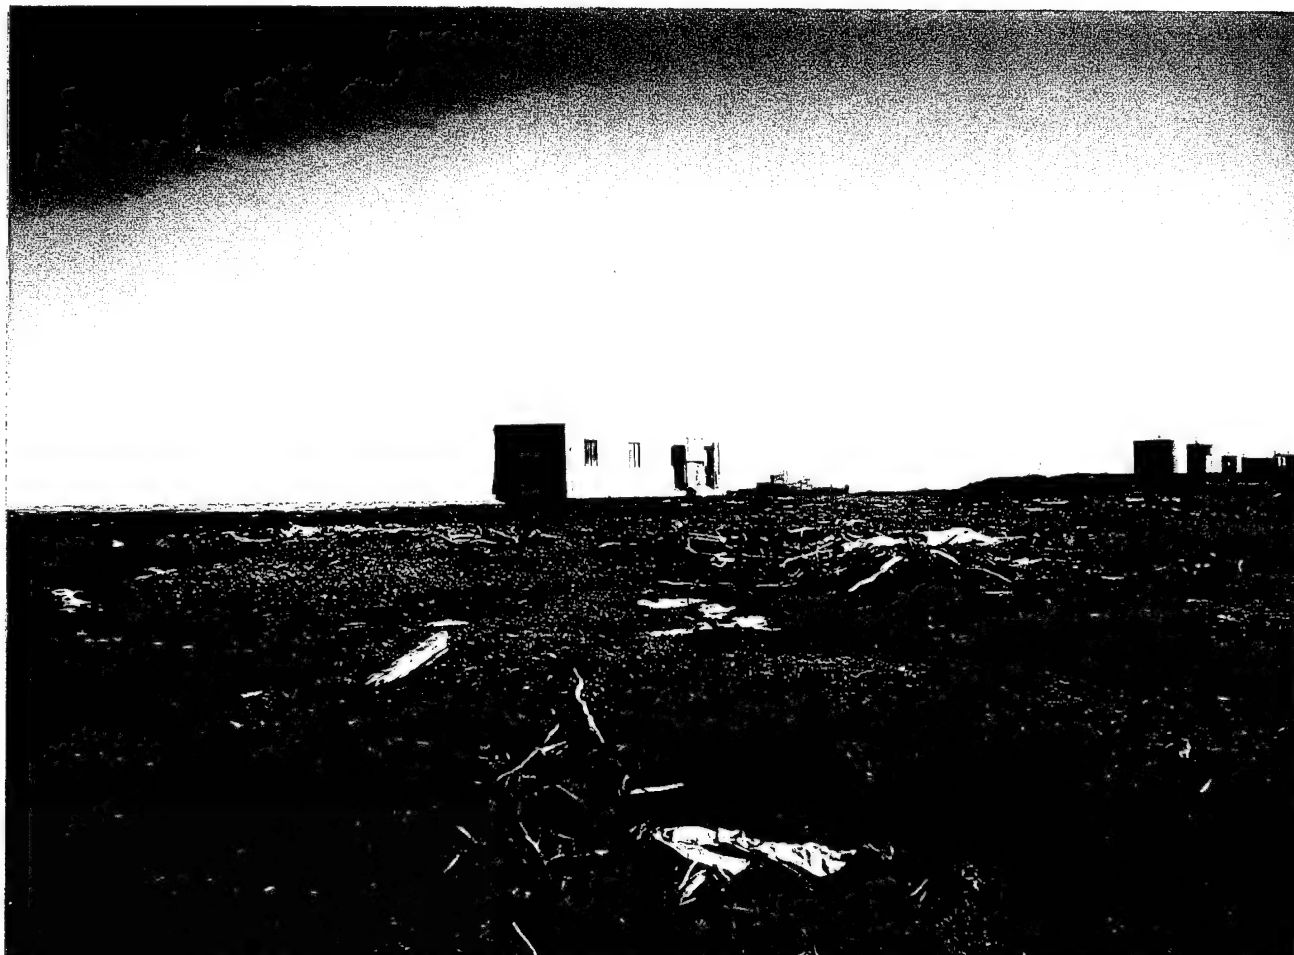
The Old Landfill (LF01) site is the location of the old station dump that received all wastes generated by the station, other than those that were incinerated, from 1956 to approximately 1978. This is a view to the northeast.

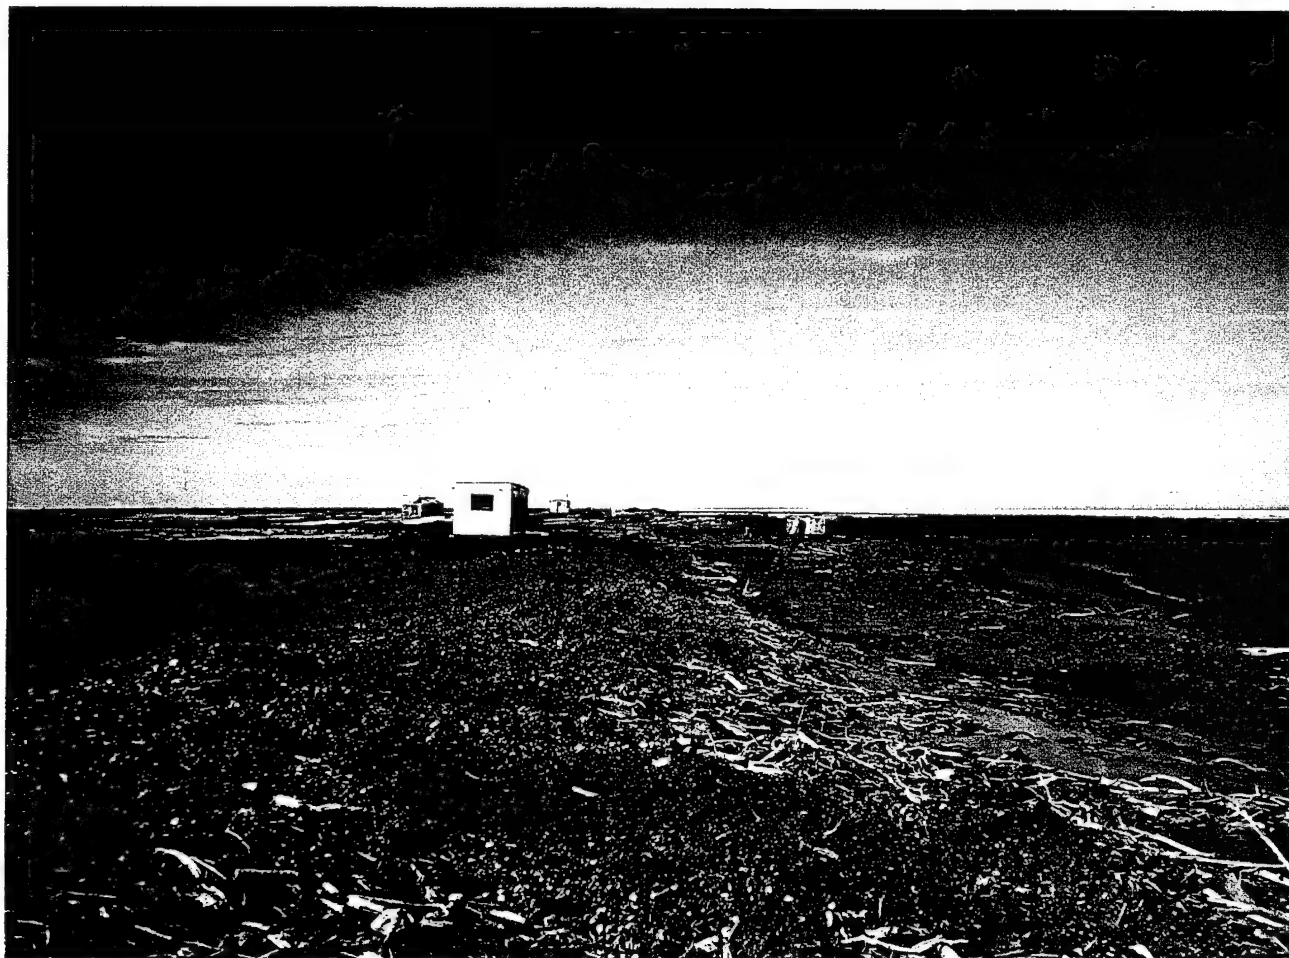
The Dump Site (LF02) site is located east of the Old Landfill (LF01) and north of the Dock Storage Area (ST03). This view is to the west.

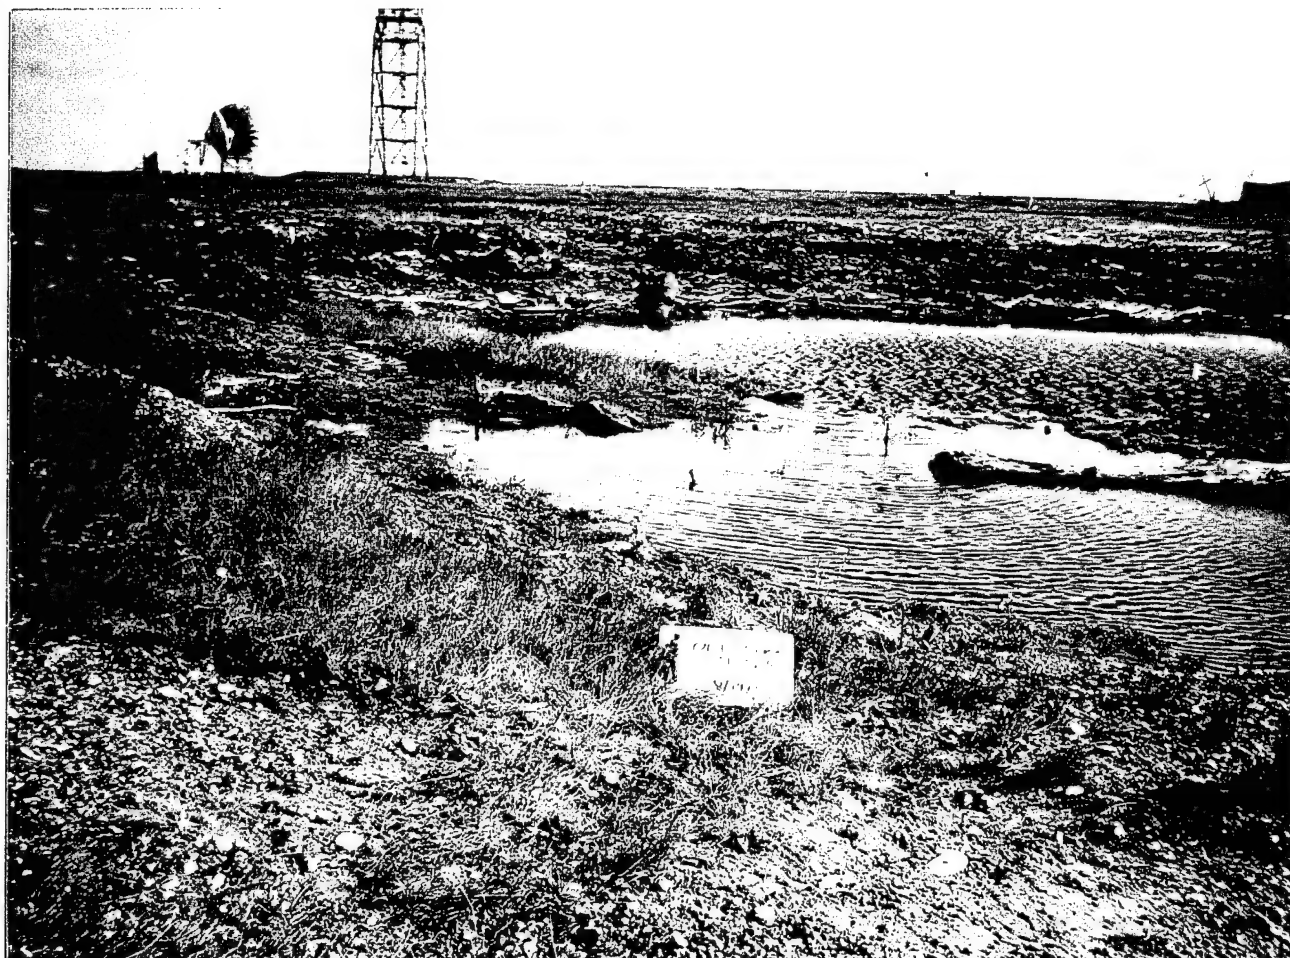
This is a view to the southeast of the Dock Storage Area (ST03) site. Drums were removed from this site prior to 1987.

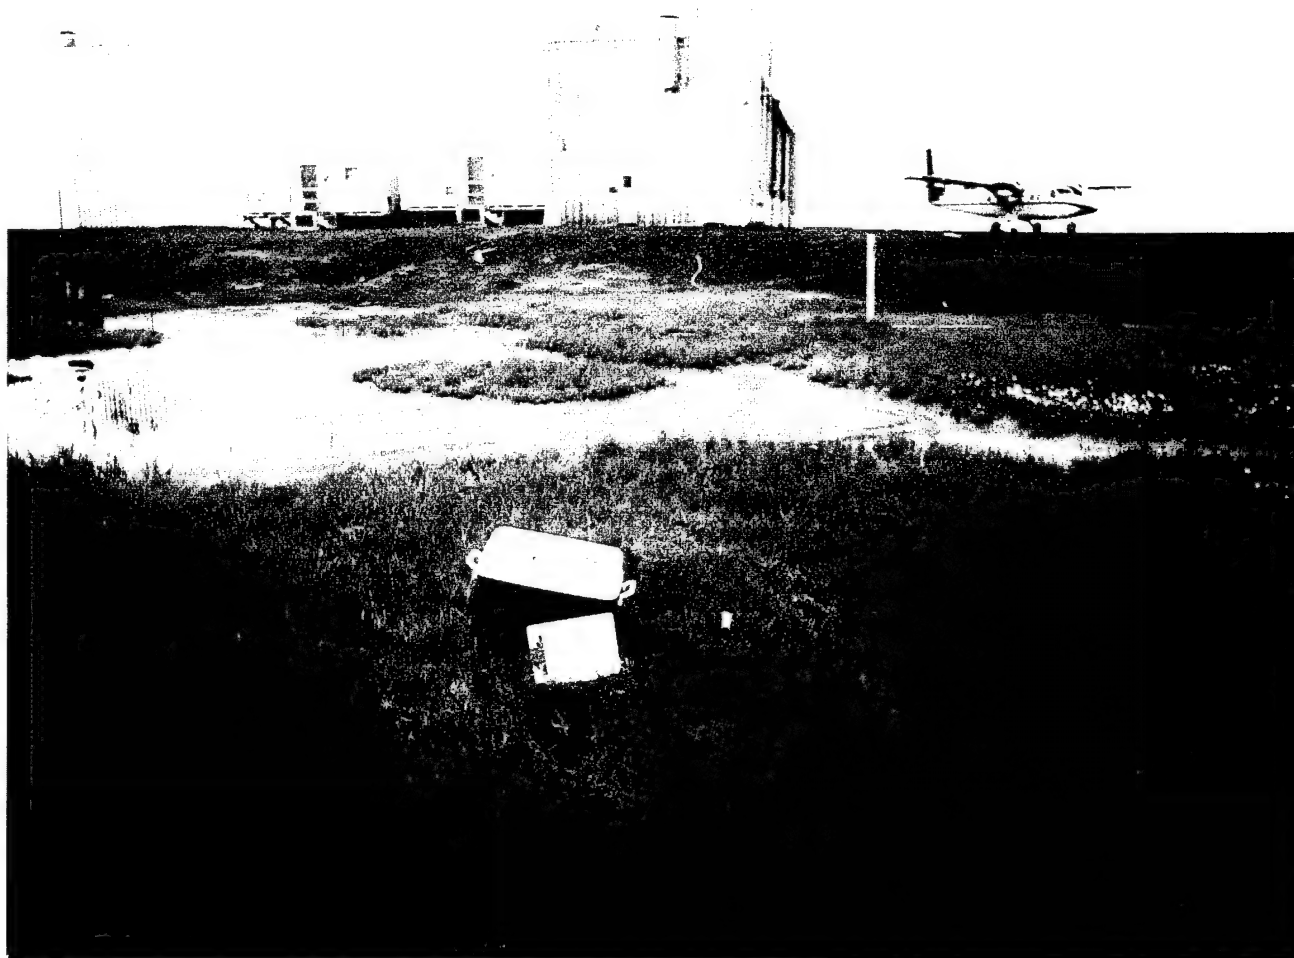
A view to the west of the Diesel Spill (SS05) site. The site is adjacent to the east side of the hangar.

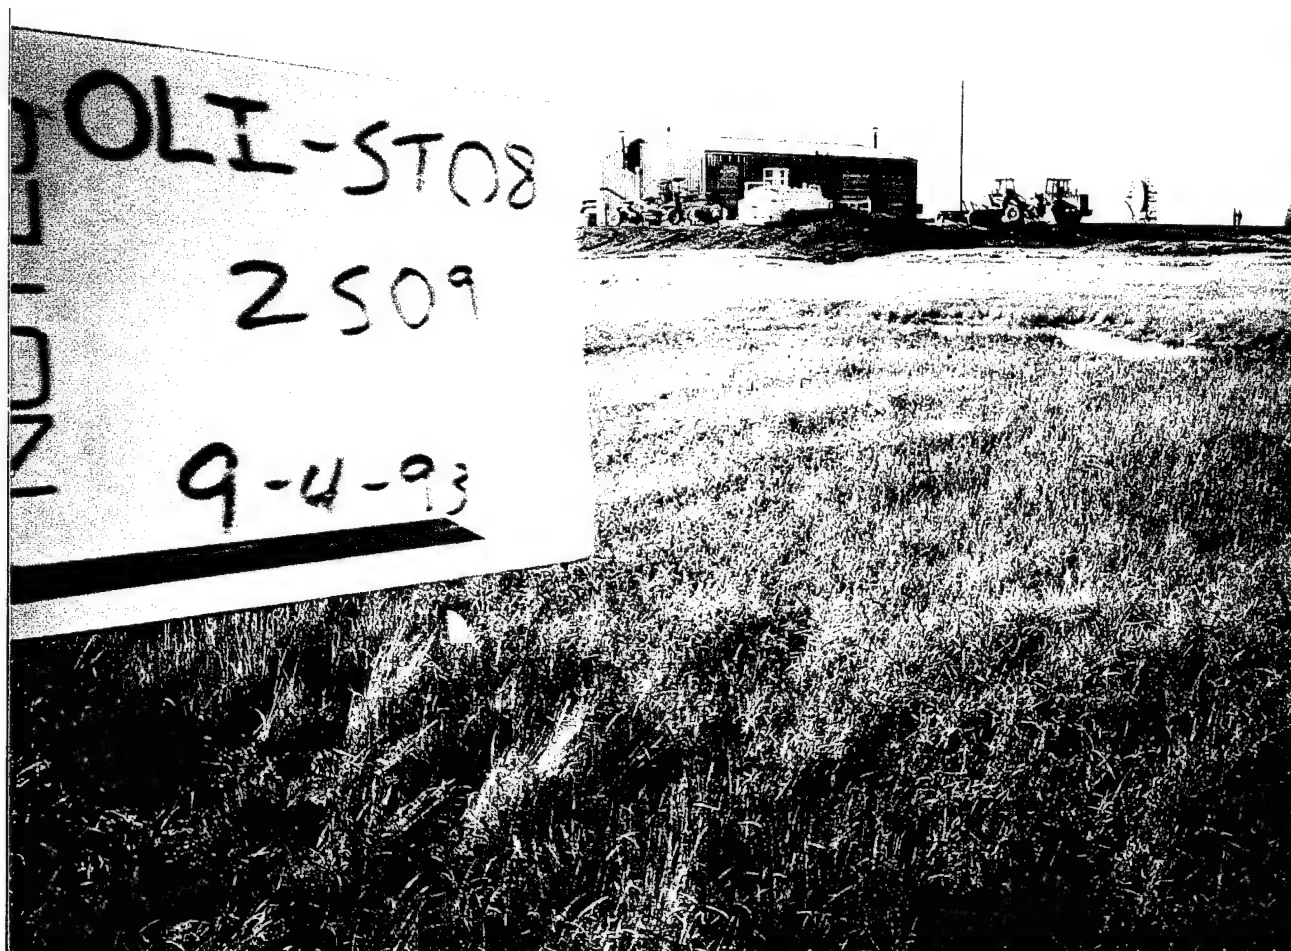
This is a view to the south of the Gasoline Storage Area (ST08) site. Two steel diesel storage tanks were formerly located on the gravel pad in front of the garage. The site extends out into the tundra.

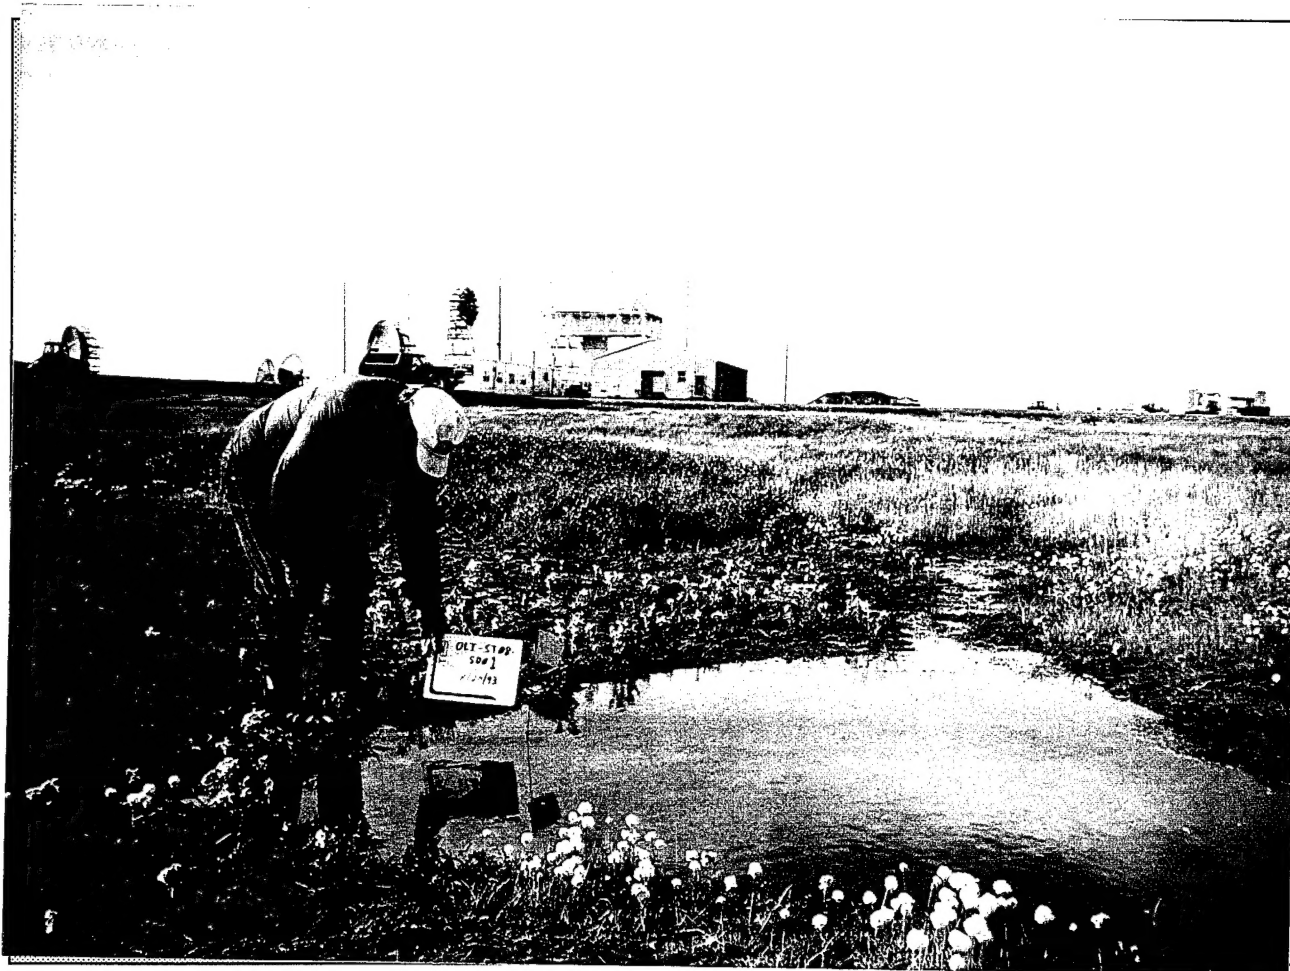
This view is to the southwest of the Gasoline Storage Area (ST08) site. The gravel pad and Garage (SS10) site are located just to the left of this photo.

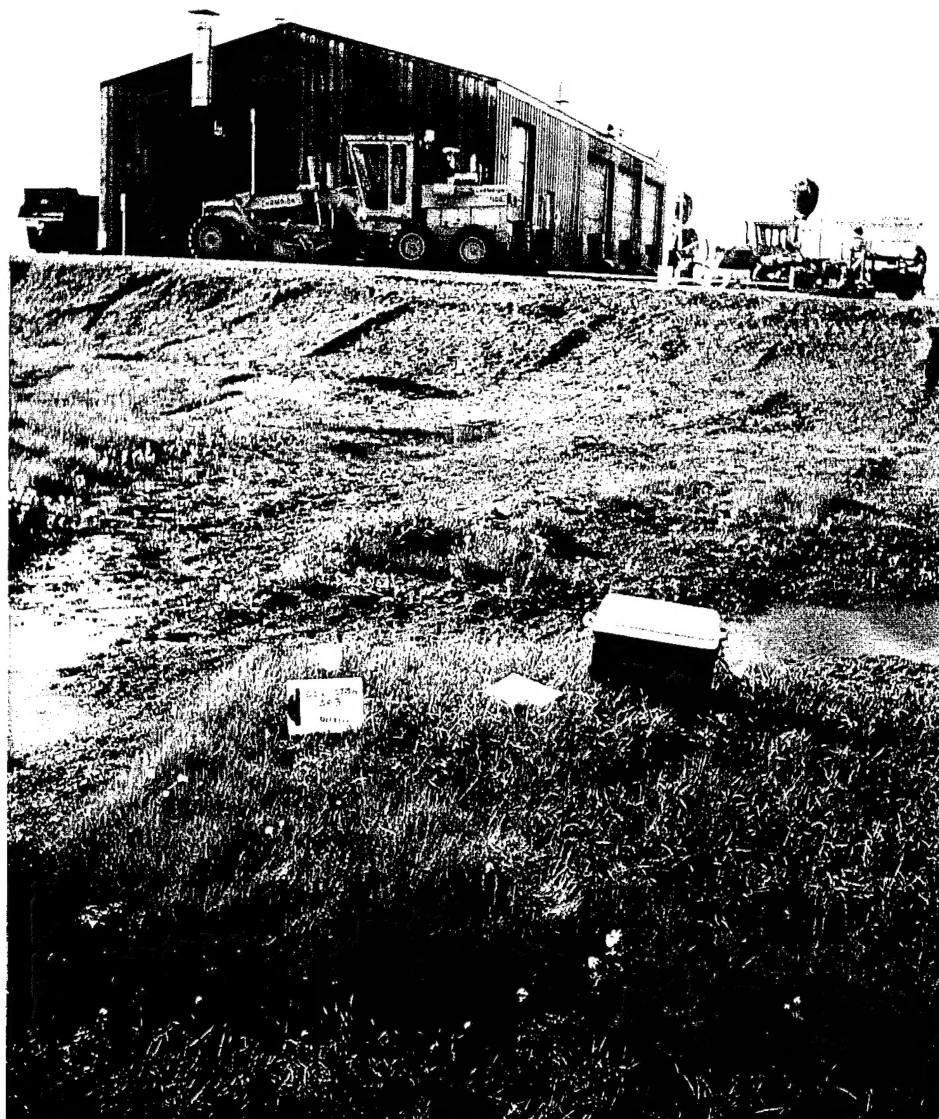
The Garage (SS10) site and the Gasoline Storage Area (ST08) site are adjacent. Samples were collected in the tundra in this photo for the Gasoline Storage Area (ST08) site; the Garage is located on the gravel pad.
